## Some notes on Arreton Flooding 17 August 2022

### Introduction

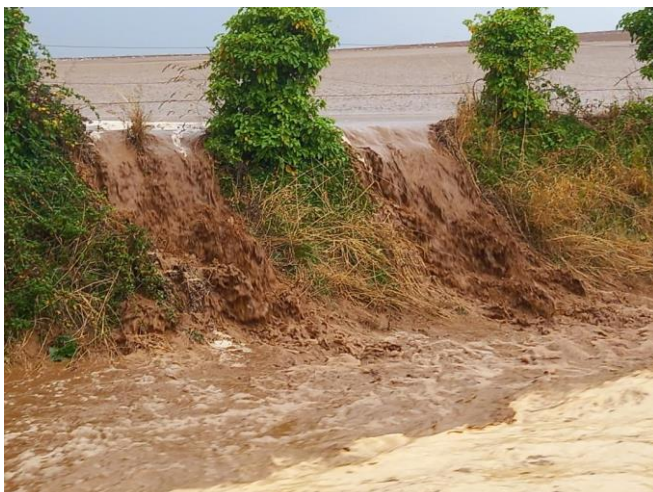
Picture 1 Agricultural run-off at the drainage chamber near to Primrose Dell

There is a collection chamber and a pipe under the road near to this. This looks dramatic but it was probably the lesser of the flows coming off the fields, with the larger flow being at the Community Centre. The location of the flows coming off the fields at the Community Centre is shown below.

Superficially the easiest improvement would be to increase the size of the pipe under the road near to Primrose Dell. This is a 300mm diameter pipe, and increasing this to, say, 450mm diameter would more than double its capacity. There would also need to be some earthworks in the field and possibly an increase in the size of the chamber. However, the effect of this would be to discharge into a watercourse upstream of Carpenters Yard; properties there are currently at risk of flooding, and this would almost certainly increase the probability of them flooding. Thus, unless work was done to

Another potential intervention, the practicality of which would need to be investigated, would be to construct a balancing lagoon immediately adjacent to the pipe under the road. This would be an earth lagoon with a low-level small diameter pipe outlet and a high level overflow. The effect of this would be to dampen peak flows and hopefully prevent extremely high discharges. This appears possible and if implemented should in the event of another reduce the overflow discharging onto the Main Road. This appears practical but would not have made much difference in a storm of the intensity experienced last week. **There are several recommendations that would go some way to reducing the risk of flooding. Land management by the landowners to ensure that they retain and manage the surface water from their land before it affects the highway. This would be the excavation of ditches along the hedge line which would accept surface water run-off and incorporate some means of filtration prior to it entering the culvert as this would prevent silting. This naturally leads on to the requirement for an improved culvert system to facilitate the effective removal of water from the ditches. The current culverts pass beneath the highway and then deposit into an unnamed watercourse behind the residential properties. The culvert system varies in diameter and a new system would increase capacity therefore improving the transfer of surface water from the agricultural areas to the watercourse. This would require a suitable engineering project that had a reduced impact on the property owners, i.e., not excavating gardens and driveways.**

To reduce the flooding derived from the low point near to Primrose Dell, it does appear practical to construct a balancing lagoon. This would reduce flow and significantly dampen peak flow off the fields. Simply increasing the capacity of the existing drain pipe under the road would reduce flow reaching the road but would increase the risk of Carpenters Yard properties flooding.

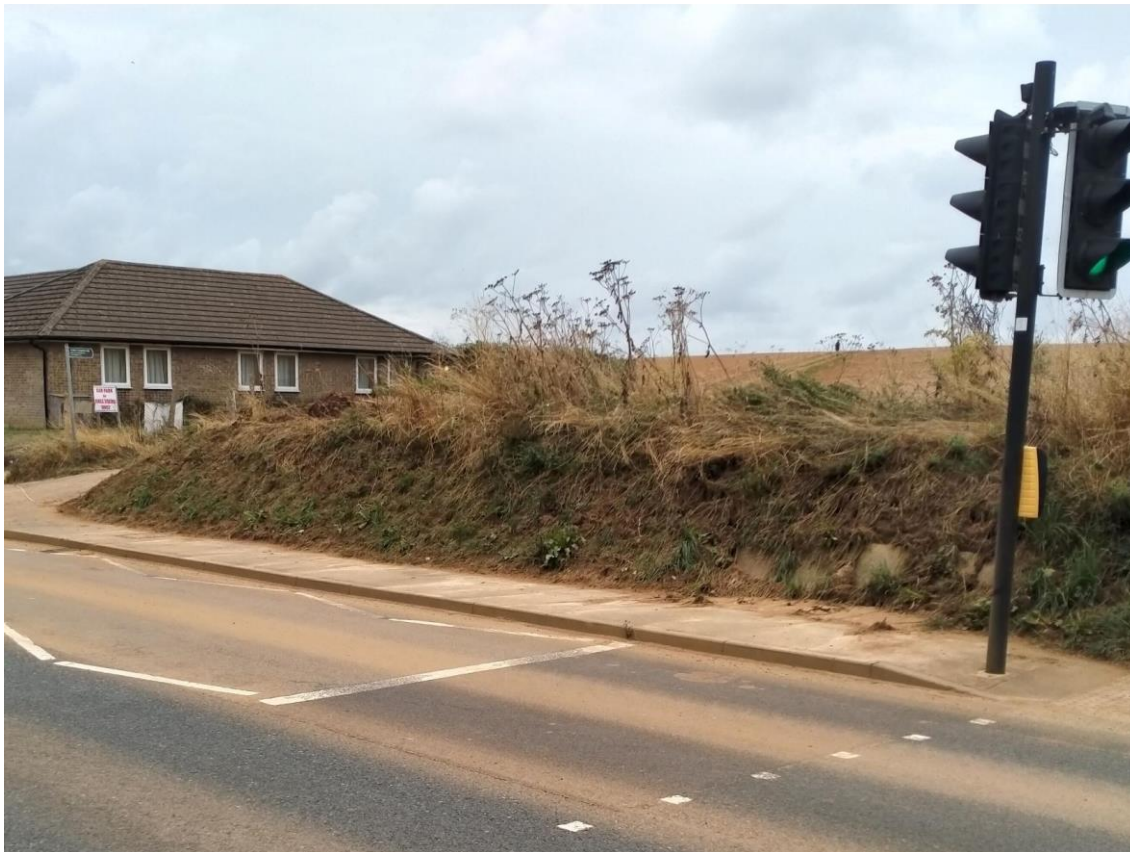
Picture 2 The flood water came down the access to the Community Centre and over a 10metre length of bank between the Community Centre and the traffic lights.

With respect to the flooding derived from the fields behind the Community Centre it is difficult to see an engineering solution to prevent flow onto the road in the event of a repeat of last weeks events.

To reduce the flooding derived from the fields adjacent to the Community Centre, the only realistic option appears to be either to use the fields as pasture rather than for arable crops. Alternatively, a strip of pasture or shrub or woodland might reduce flow and would intercept silt.

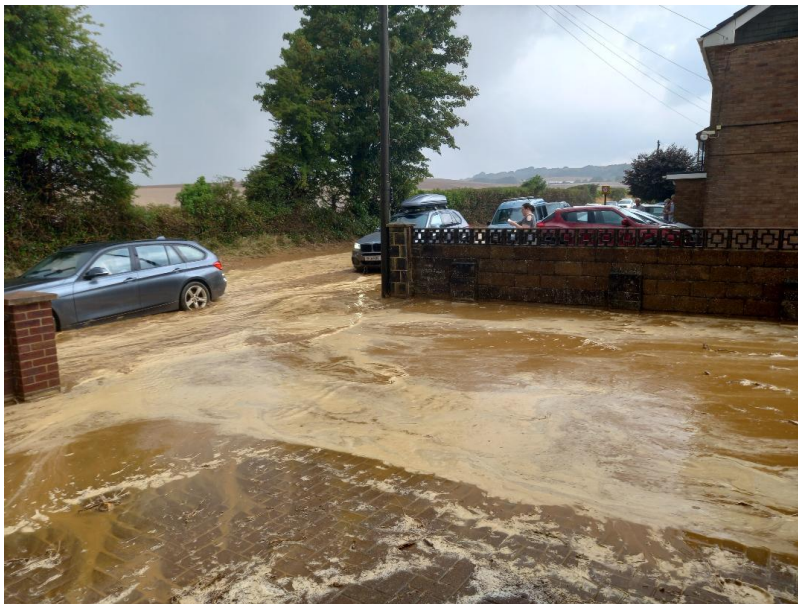
Flooding through the village was extreme with a torrent through much of the village, as shown in the photo below, although this does not fully capture the rate of flow.

Picture 3 Flooding and traffic in the village

One compounding factor for some properties was the speed at which some vehicles drove through the flood causing waves which pushed water and silt into properties that otherwise would have been minimally affected. However, for the seriously affected properties this was not significant.

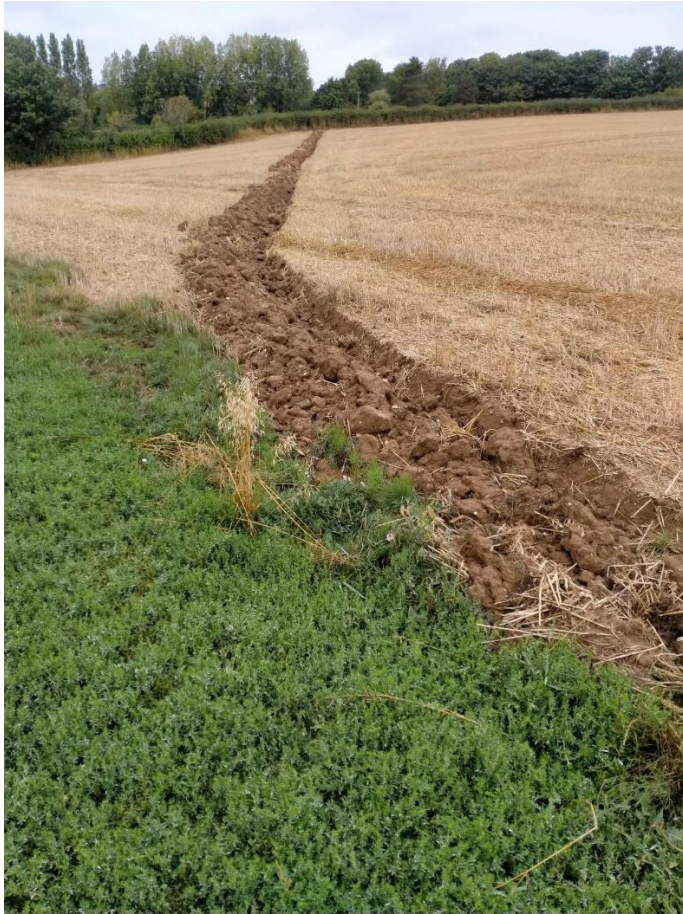
A previous event in 2021 caused extensive flooding with water running off the agricultural land running up to Arreton Down, particularly affecting properties in Carpenters Yard. This time inspection of the site of the 2021 flooding showed that some silt had been deposited on the A9 bridle path at its junction with footpath A13. However, of the two fields from which the flow came, one was planted with maize and the other had been planted with a cereal crop which had been harvested, leaving stubble. The reason for there being less flooding in this area could have been due to the fields having vegetation in, and/or possibly having had less intense rainfall. The picture below shows the stubble (with a trench dug subsequent to the flooding). Whether due to the crops or due to less intense rainfall on the fields the flooding in this area was much less severe than in 2021. **Noted and agreed**

Picture 4 Stubble in a field north of the village

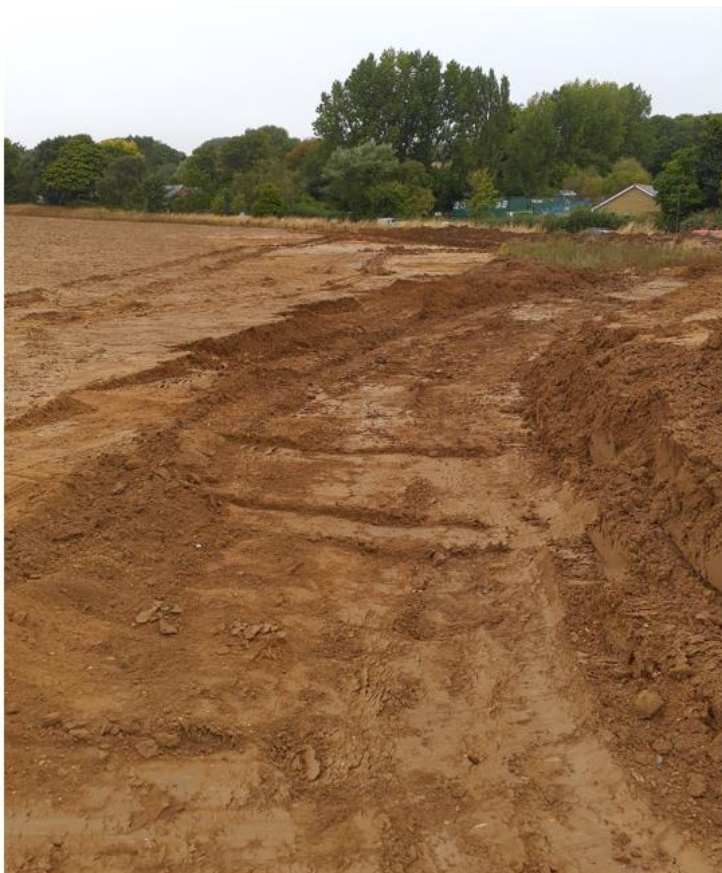
**Photograph shows an excavation by a landowner to form a ditch adjacent to the community centre.**

Since the flood there has been work in the field to construct a crude lagoon by excavating a bank of earth. This would provide some storage of flood waters but it would not have prevented all run-off.
